Case Study

Canal Walk, Portsmouth Access Point and Car Park

Canal Walk, Portsmouth Access Point

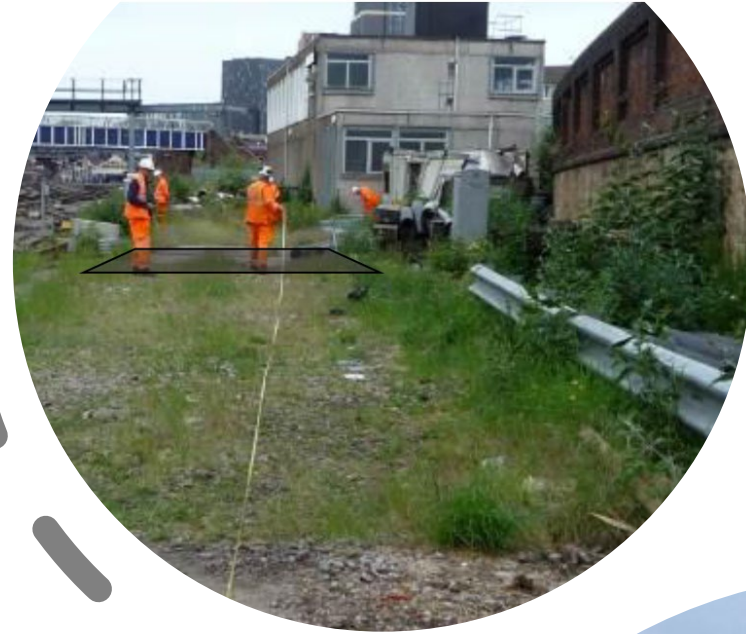
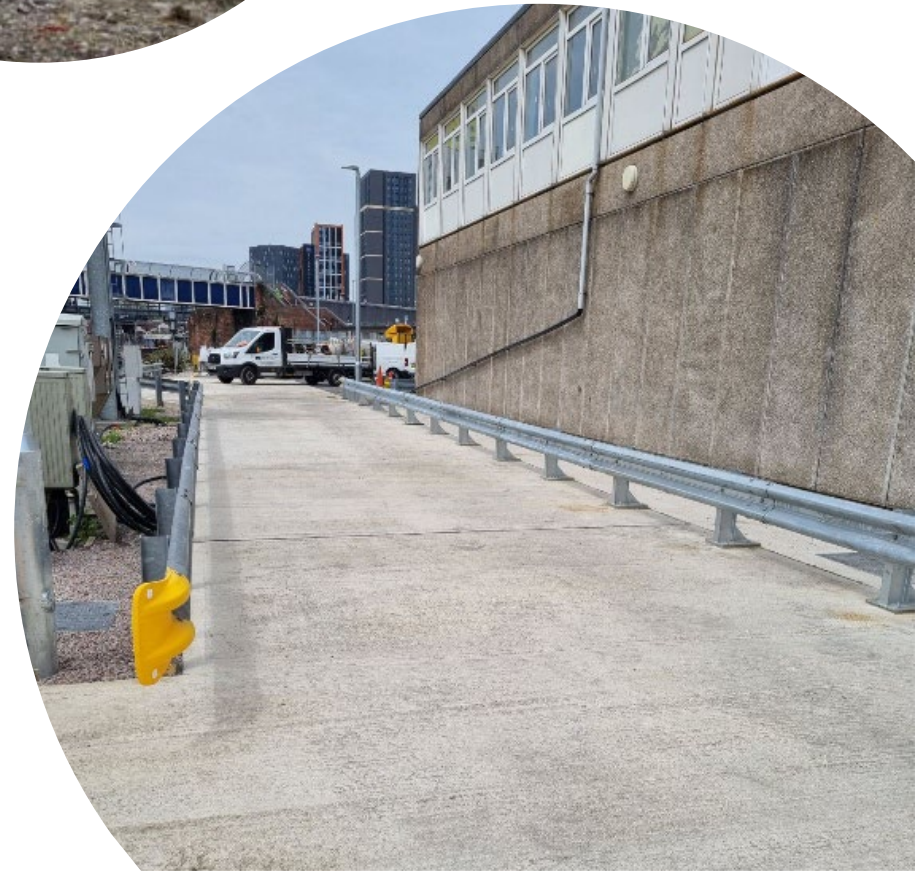
Network Rail identified several issues with the existing authorised access point at Canal Walk in Portsmouth. The issues included that there was no permanent RRAP installed at the existing RRV access point. There was no designated area within the Network Rail boundary to carry out safety briefings, start of shift briefings or toolbox talks.

There was no designated space for loading/unloading or storing materials, the existing cabin was deteriorated beyond repair.

Other issues outlined were there were ETE & ETM cables running through the road rail access point footprint and the ramp leading to the rail level is too steep, causing the lorries to bottom out causing damage to vehicles and to the infrastructure.

A points heating transformer had been situated within a verge which was constricting the haul road access and the original drainage within the site compound appeared to be blocked and non-functional.

Working alongside Balfour Beatty Rail as the principal contractor and Network Rail as the client Seva Rail undertook the groundwork, civils, drainage and cable management works that were required to get the access point brought up to today's standard and ensure the environment on site was as safe and user friendly for the track workers as possible.

Over a 12-week programme Seva Rail successfully carried out clearance works, de-vegetating the area to allow the works to start. First to secure the site we installed 1.8m high palisade fencing with new double gates and set to work on the groundwork including new drainage, sub-base, kerbing and vehicle barriers as per the supplied design.

The haul road sectional slab was poured in stages to minimise the affect to the operational access point, the car park itself was resurfaced with tarmac with areas segregated using fencing as well as rubber demarcation.
